COMMON PRACTICE LIGHTNING STRIKE PROTECTION CHARACTERIZATION TECHNIQUE TO QUANTIFY DAMAGE MECHANISMS ON COMPOSITE SUBSTRATES

George N. Szatkowski, Kenneth L. Dudley, Sandra V Koppen, Jay J. Ely and Truong X. Nguyen
NASA Langley Research Center
Hampton, VA 23681 U.S.A.
George.n.szatkowski@nasa.gov

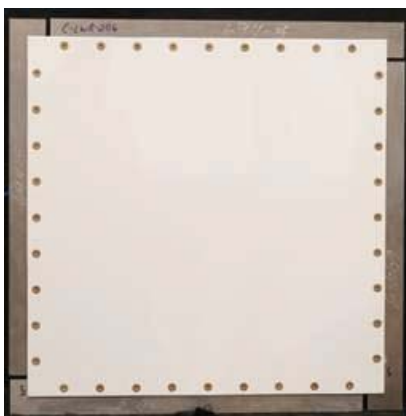
The panels have countersunk fastening with 2 inch spacing. Each panel is fastened to four independent aluminum ground bars. Common steel or CRES fasteners are used to provide a conductive path from the panel to the frame and eventually into the test equipment ground. Figure 1 shows a test panel with ground bars attached.

Figure 1. Photograph of CFRP Test Panel

3K-70-PW) preregs, coated with a typical aerospace primer (0.5-1.5 mils thick) and paint (4-6 mils thick) finishing scheme. The finished panels are attached to aluminum grounding bars intended to draw electrical current from the lightning attachment point to the panel edges and thus to ground. The protected configuration contains a top LSP layer made up of Cytec Surfamaster 905C Composite Surfacing Film above Dexmet 3CU7-100FA expanded copper foil and is included in the laminate stack up prior to cure. The laminates are to be designed per common aerospace industry practices (balanced, symmetric and sequence). The typical lightning strike panel will be quasi-isotropic in nature with a fabric ply on each side of the laminate. The laminate stack is defined as follows; 16 ply tape with 2 ply fabric (as follows):[(0/90F)/45/90/-45/0/45/90/-45/0/0/-45/90/45/0/-45/90/45/(0/90F)].
